# PROPERTY INSPECTION REPORT

Concerning: 123 Congress Ave., Austin, TX 78701  
(Address or Other Identification of Inspected Property)

By: Roland Huettel, Professional Real Estate Inspector, TREC #4849, Building Analyst, BPI #06583  
(Name and License Number of Inspector) (Date)

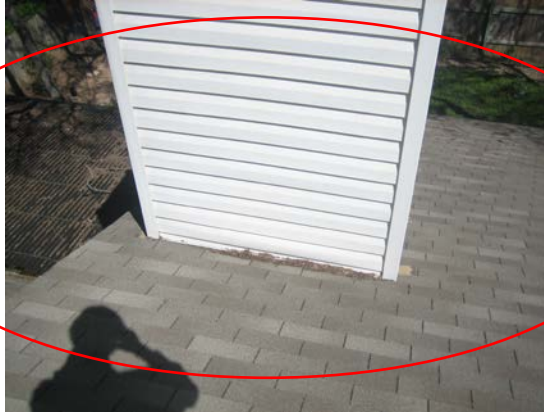
> No chimney cricket flashing was installed at 5' wide chimney back. Client should consider keeping debris from accumulating behind chimney on a regular

maintenance basis (to prevent roof run-off from backing up and causing a leak) or installing an adequately sized chimney cricket flashing.  
**"A cricket or saddle shall be installed on the ridge side of any chimney greater than 30 inches wide."**  
**(SEE International Residential Code, R905.2.8.3)**

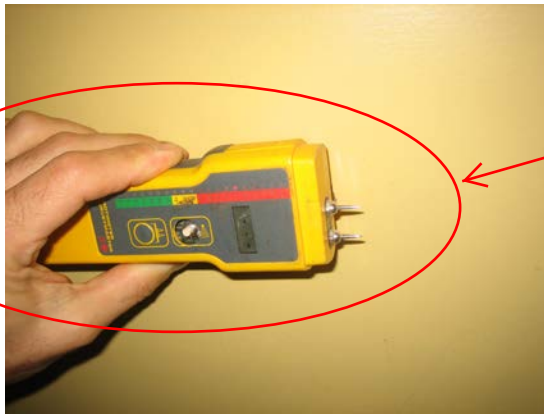
> Elevated moisture levels (>50%) were **measured with moisture meter** in electric resistance mode (non-destructive) below leaky cold-water shut-off valve to washer connection in laundry room. Client was advised to remove drywall to further investigate extent of any concealed moisture damage in wall cavity.
