# PROPERTY INSPECTION REPORT

Roland Huettel, Professional Real Estate Inspector, **TREC #4849**

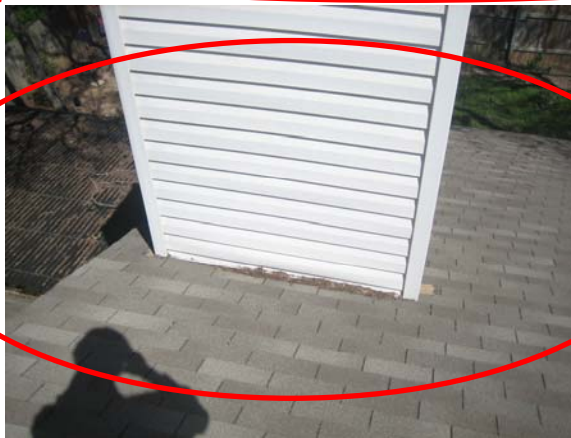
> **No chimney cricket flashing was installed at 5' wide chimney back. Client should consider keeping debris from accumulating behind chimney on a regular maintenance basis (to prevent roof run-off from backing up and causing a leak) or installing an adequately sized chimney cricket flashing.**

“A cricket or saddle shall be installed on the ridge side of any chimney greater than 30 inches wide.”

**(Building Code Reference: IRC 2000, R905.2.8.3)**

> No chimney cricket flashing was installed keeping debris from accumulating behind chimney on a regular maintenance basis (to prevent roof run-off from backing up and causing a leak) or installing an adequately sized chimney cricket flashing.  
"A cricket or saddle shall be installed on the ridge side of any chimney greater than 30 inches wide."  
(Building Code Reference: IRC 2000, R905.2.8.3)

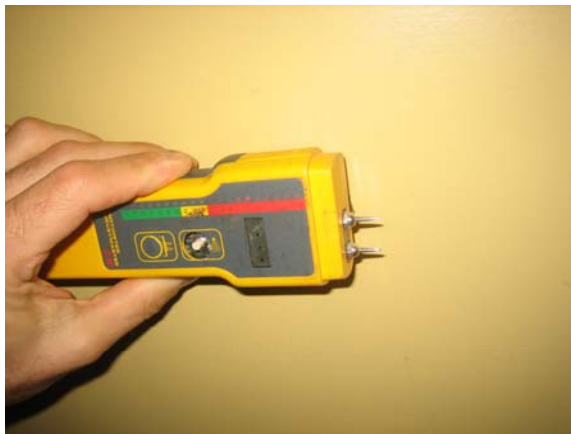
> Elevated moisture levels (>50%) were **measured with moisture meter** in electric resistance mode (non-destructive) ~~below leaky cold-water shut-off valve~~ to washer connection in laundry room. Client is advised to remove drywall to further investigate extent of any concealed moisture damage in wall cavity.

> Elevated moisture levels (>50%) were measured with moisture meter in electric resistance mode (non-destructive) below leaky cold-water shut-off valve to washer connection in laundry room. Client is advised to remove drywall to further investigate extent of any concealed moisture damage in wall cavity.
