eco.inspections, Inc.  
(512) 784-3429  
[www.ecoinspections.com](http://www.ecoinspections.com)

# PROPERTY INSPECTION REPORT FORM

**Roland Huettel, Professional Real Estate Inspector, NY ID# 16000169968**

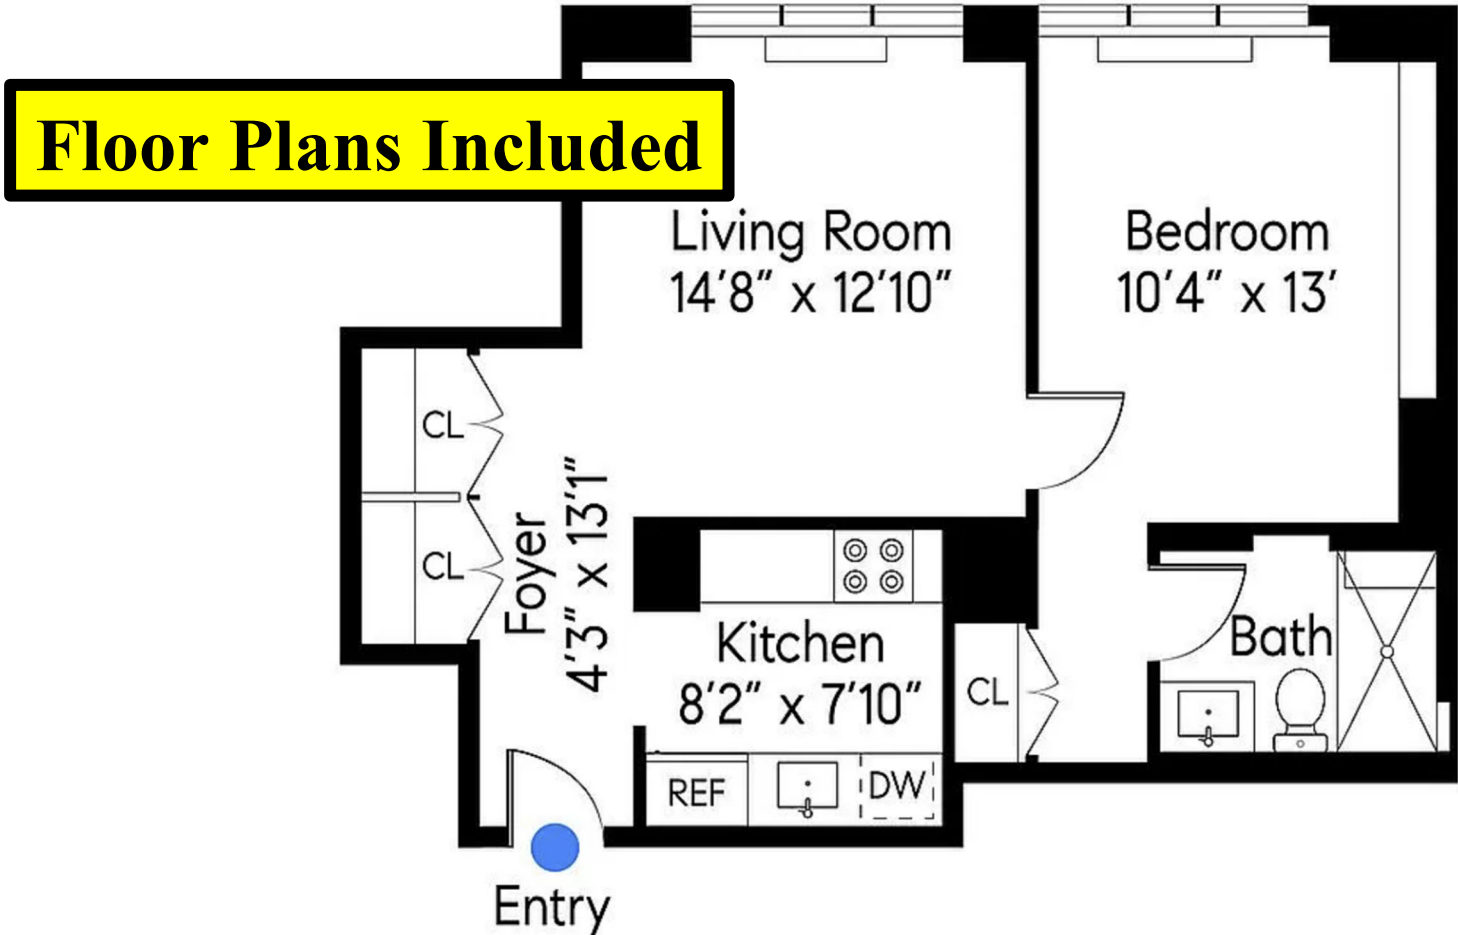
> Built in 1986. Approx. 600 sq.ft. per listing agent.  
The 27-story condominium building at [REDACTED]  
[REDACTED] uses a deep pile foundation. Given the high-rise structure built above solid bedrock, this type of foundation provides the necessary load-bearing stability for the Manhattan bedrock below.

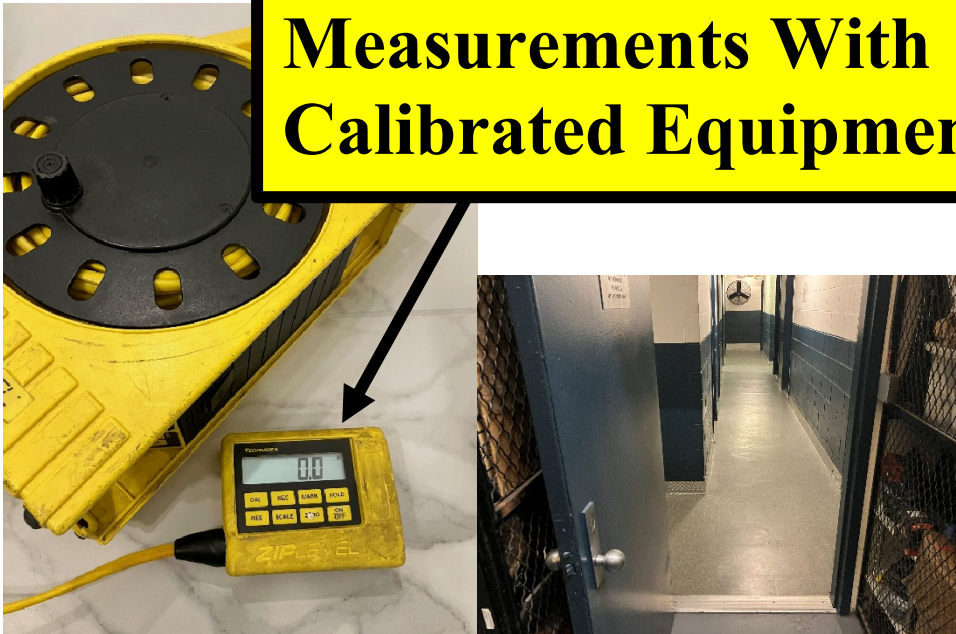
# Foundation Elevation Measurements With Calibrated Equipment

> Zip level measurements were taken inside unit on 5<sup>th</sup> level and in the basement of building (outside of unit). Measured elevation differentials were within acceptable tolerances.

> The foundation appeared to be properly supporting all imposed loads at the time of the inspection. No evidence of excessive movement or structural failure was observed.  
*Note:* not all of foundation was accessible at the time (limited access to basements).

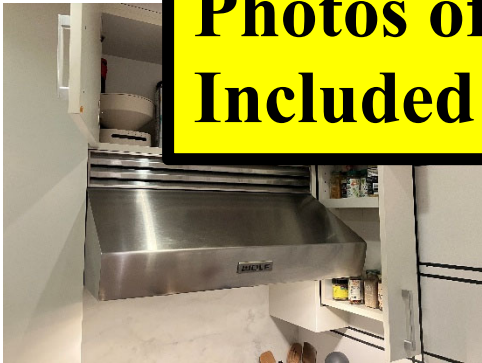
> Custom cabinets were installed in the kitchen. All functional.

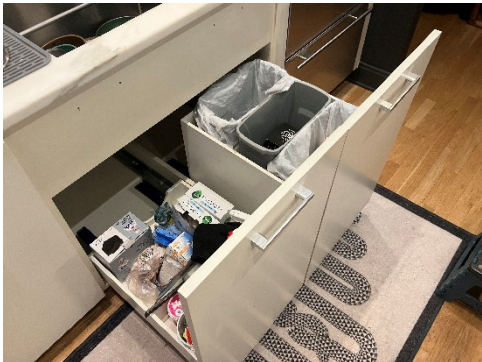
> Undersink storage for cleaning products and trash was provided.

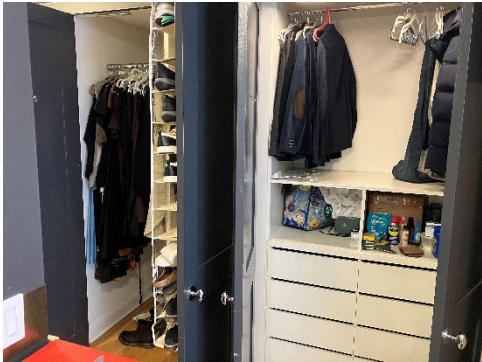
> Large hallway closets with drawers were provided.

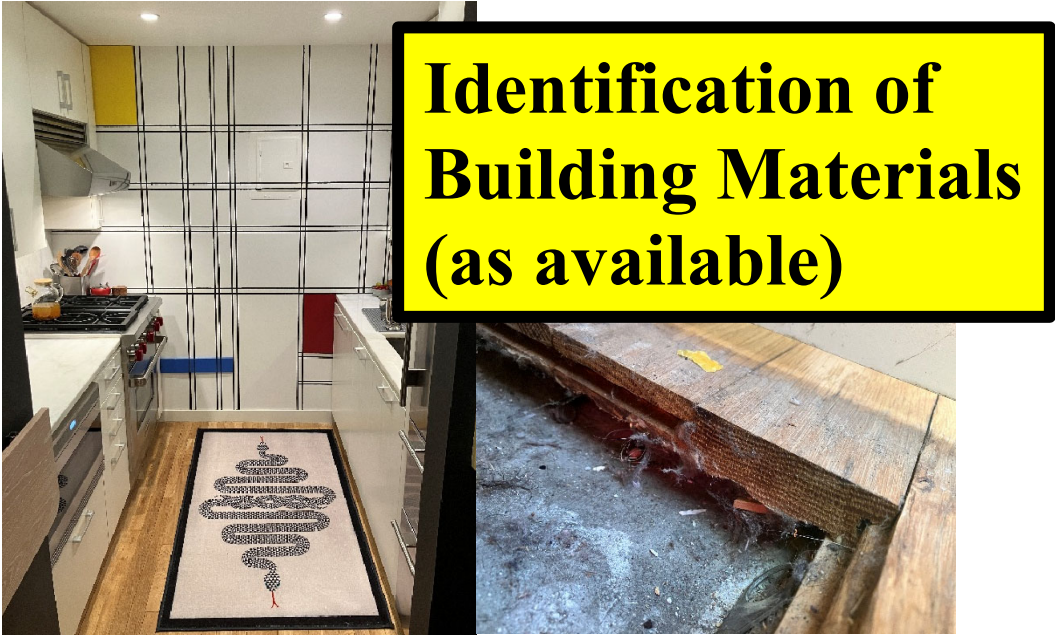
> A “floating” solid tongue & groove wood floor was installed in kitchen/hallway/living room/bedroom.

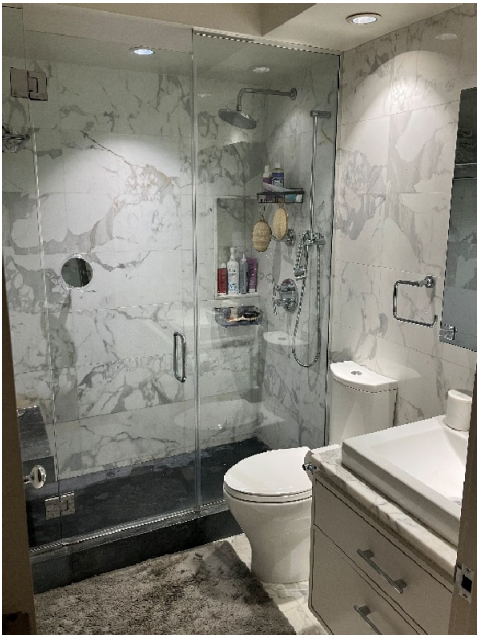
> Marble floor tile appeared to be installed in the bathroom.

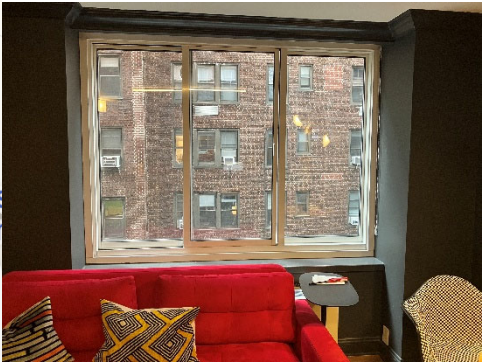
> Dual pane insulating glass windows were installed. Aluminum frame, horizontal sliders. Windows in both living room and bedroom were facing SSE.

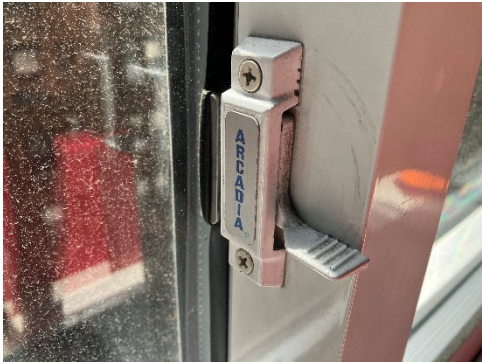
> Windows by Arcadia.

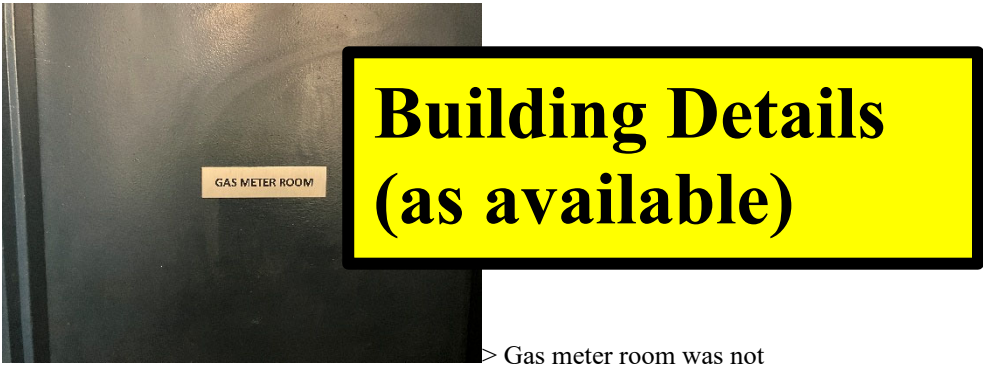
> Gas meter room was not entered/inspected.

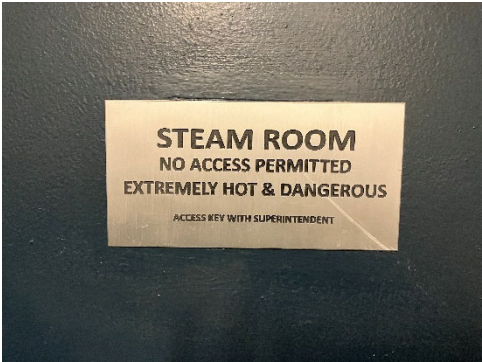
> Steam room with boilers and water heaters was not entered/inspected.

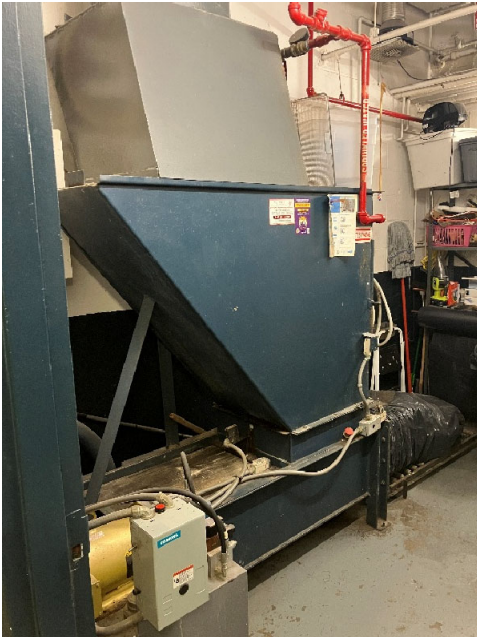
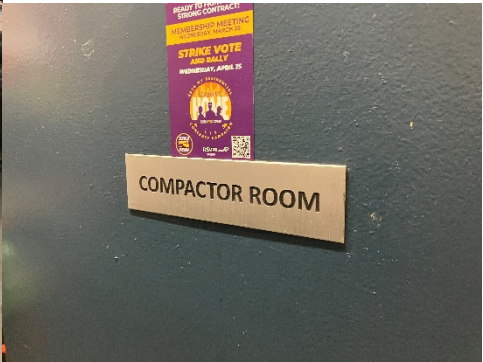
> Trash compactor was installed in basement. Not inspected.

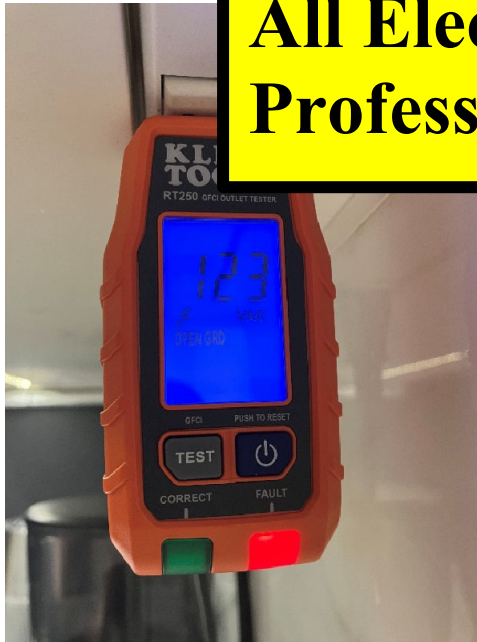
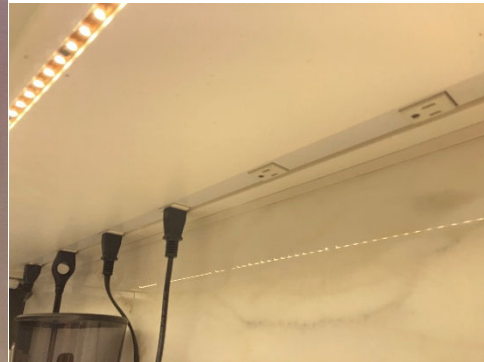
> A total of 16 outlets provided in kitchen were not GFCI protected for occupant safety.

Open grounds were noted at all 16 outlets in kitchen. Safety concern. Recommend further consultation by a licensed and qualified electrician.

Open grounds were noted at all 16 outlets in kitchen. Safety concern. Recommend further consultation by a licensed and qualified electrician.

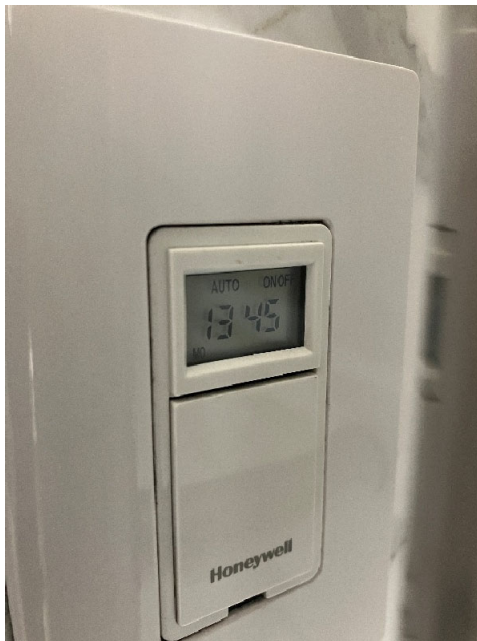
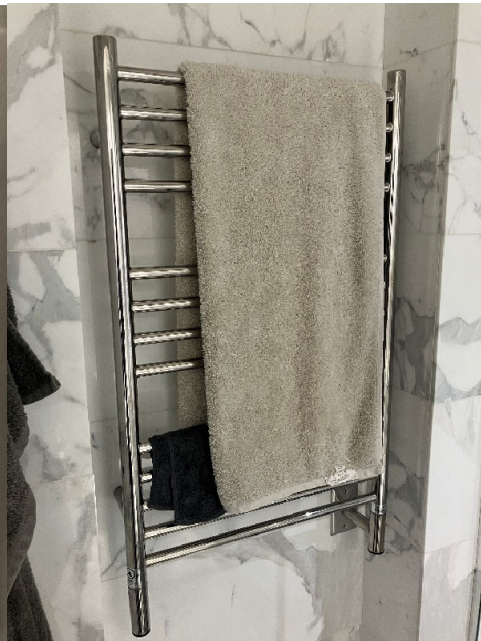
> A towel warmer was installed. Properly functional.

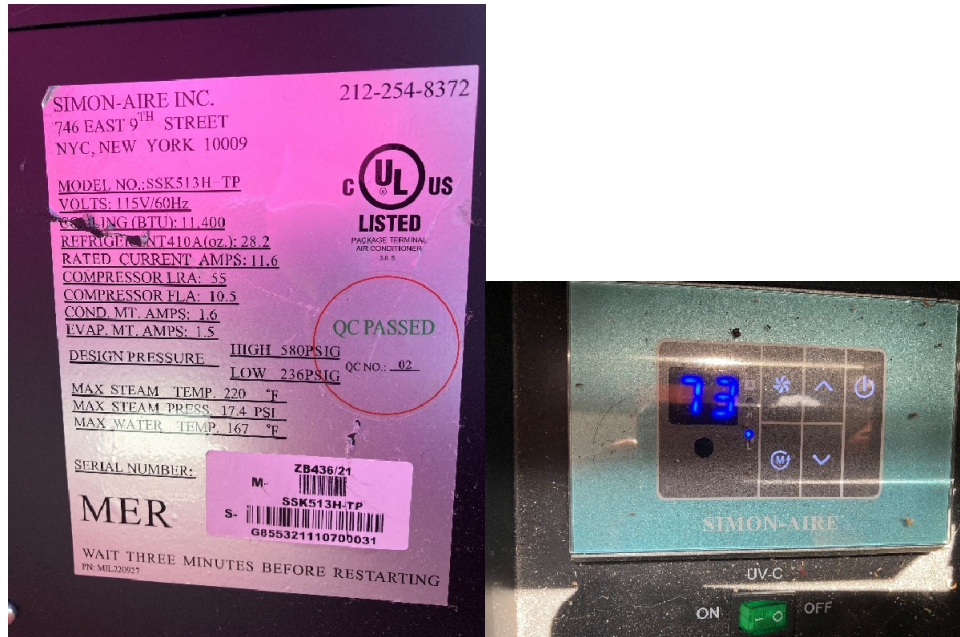
> A cooling unit by Simon-Aire from 2021 was installed in the living room. 11,400 BTUH input (1-ton capacity).

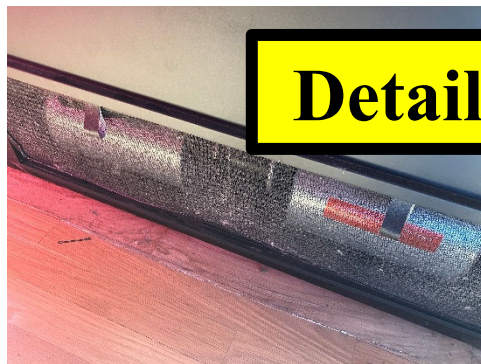
> Return air filter was installed by equipment at exterior living room wall above floor level. Clean filter installed.

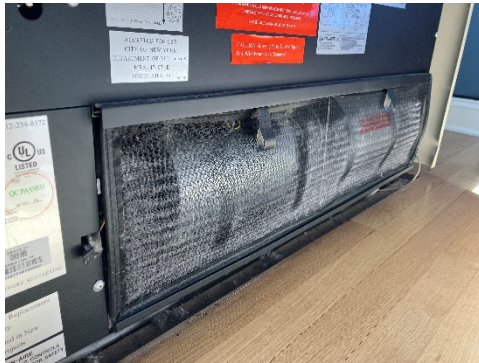
> Return air filter was installed above floor level at bedroom exterior wall. Clean filter installed.

> The cooling unit #2 appeared to be in serviceable condition at the time of the inspection.

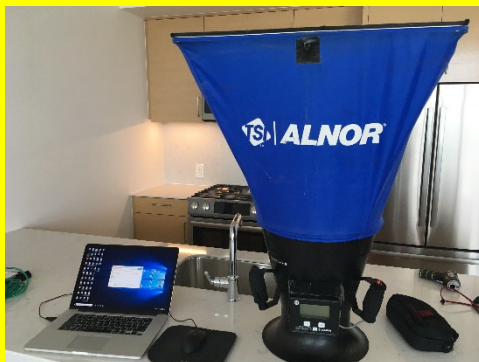
> **NOTE:** room air flow measurements (in cubic feet per minute or CFM) were taken with a calibrated Alnor balometer (see photo above) with all the interior doors opened and all supply air registers at ceilings/floors opened. The measurements are taken to allow for an educated

> Guest bedroom 237 CFM (with door closed) or 304 CFM (with door open) - 120 ft.<sup>2</sup> - 1.98/2.53 CFM/ft.<sup>2</sup> - high supply high flow even with SW-exposed window surfaces – compare to master bedroom! Also see note regarding high air pressure differential to common area below.

> Master bedroom 83 CFM (with door closed) or 101 CFM (with door open) - 145 ft.<sup>2</sup> - 0.57/0.7 CFM/ft.<sup>2</sup> - low supply air flow even considering North-exposure (small 5”x5” supply air grill was installed – compare to guest bedroom with 3x the supply air flow! This room was also measured to be 3 degrees warmer than other areas of unit during the inspection! Potential comfort issue! Recommend installing return air flow at minimum (to increase supply air flow to this master bedroom). Increasing duct size to master would also help better distribute supply air.

> Minimally sized supply air grille in master bedroom was causing poor supply air flow! See photos above for master (left photo) and guest bedroom (right side photo).

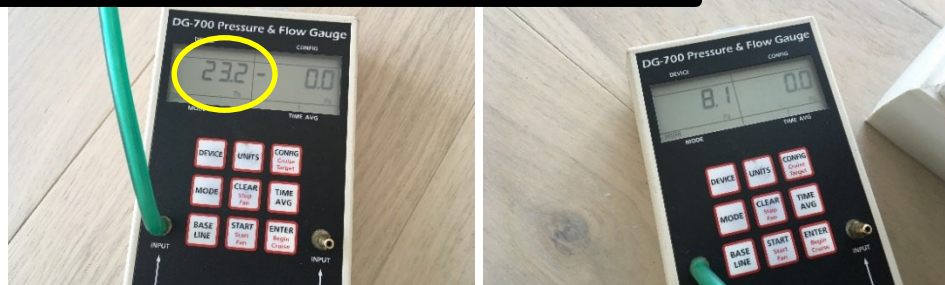
## Air Pressure Differential Testing of HVAC

> Up to 23 Pascal positive air pressure was measured with between guest bedroom and common area with return in hallway at ceiling (left photo). Recommend adding return airflow from guest bedroom as well as from master bedroom for improved indoor comfort and energy efficiency. Up to 22% supply air flow reduction was measured with guest bedroom door closed. Up to 18% supply air flow reduction for master bedroom! (right side photo - 8 Pascal air pressure differential between master bedroom and common area of unit).

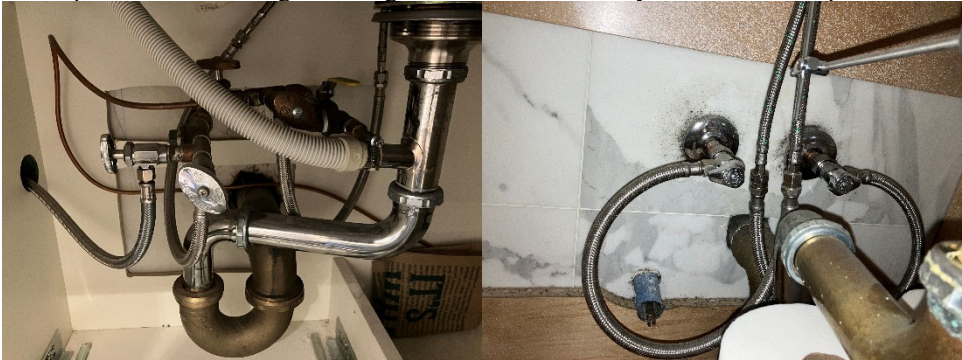
> Copper supply piping was visible below sinks in kitchen and bathroom.

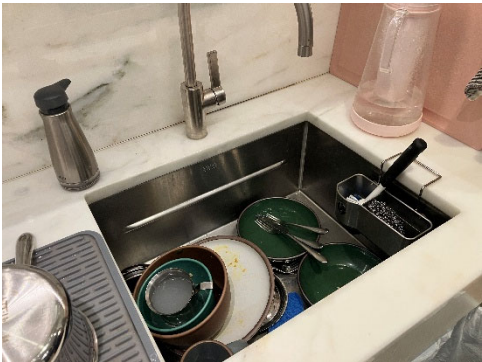
> A 9 inch deep kitchen sink was provided.

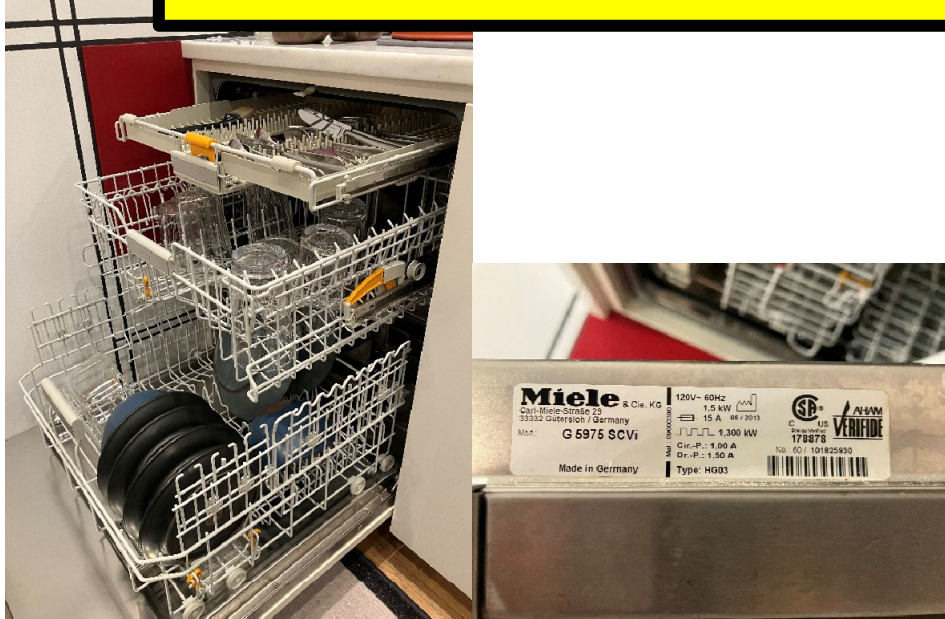
> A Miele dishwasher was built-in. Manufactured in 2013.

> The dishwasher appeared to be in serviceable condition at the time of the inspection. Unit completed normal cycle, was mounted securely and without signs of corrosion at interior. Door seals, spray arms and soap dispenser appeared to be functional.

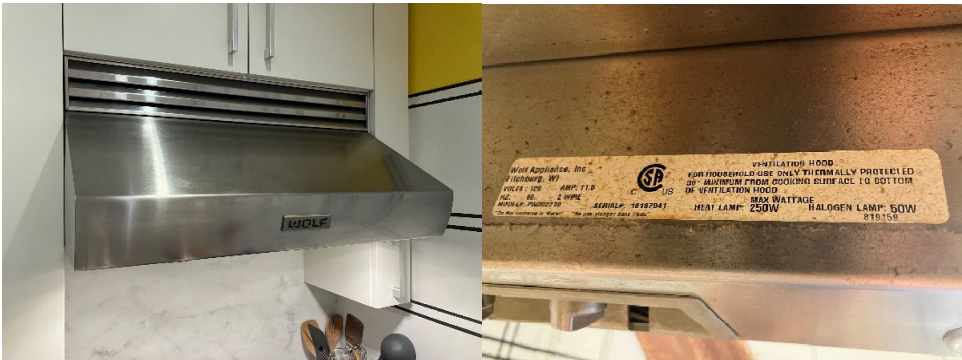
> Range hood was vented to the exterior. Manufactured by Wolf from 2016.

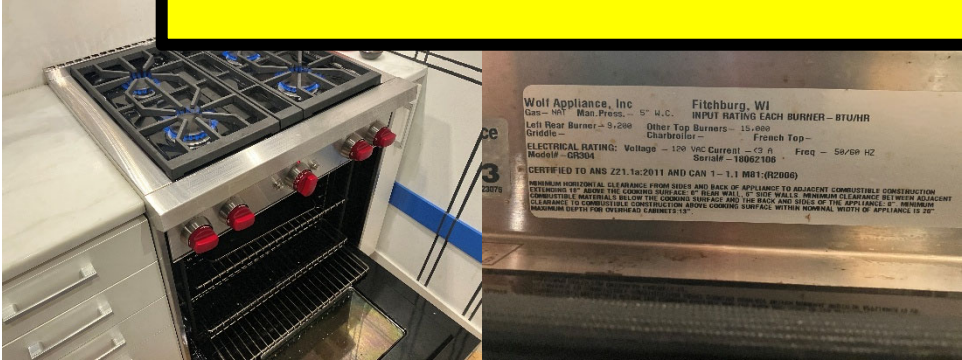
> A gas cooktop was built-in. Manufactured by Wolf from 2013.

> The cooktop/range appeared to be in serviceable condition at the time of the inspection.

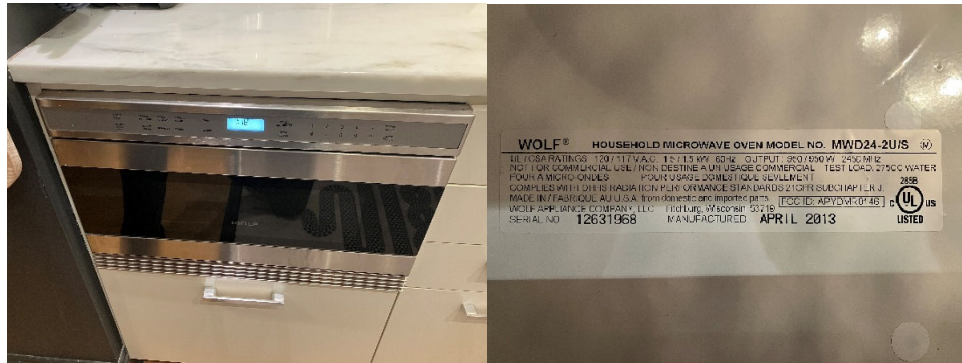
> A microwave was built-in. Manufactured by Wolf from 2013.

> The microwave appeared to be in serviceable condition at the time of the inspection.

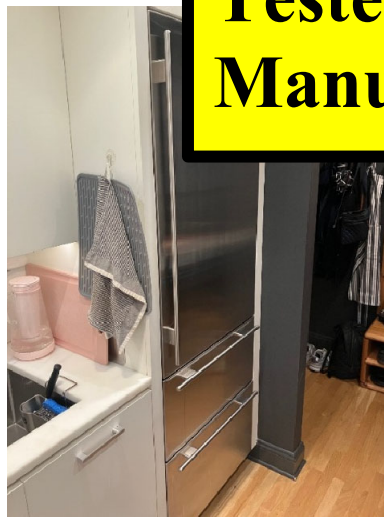
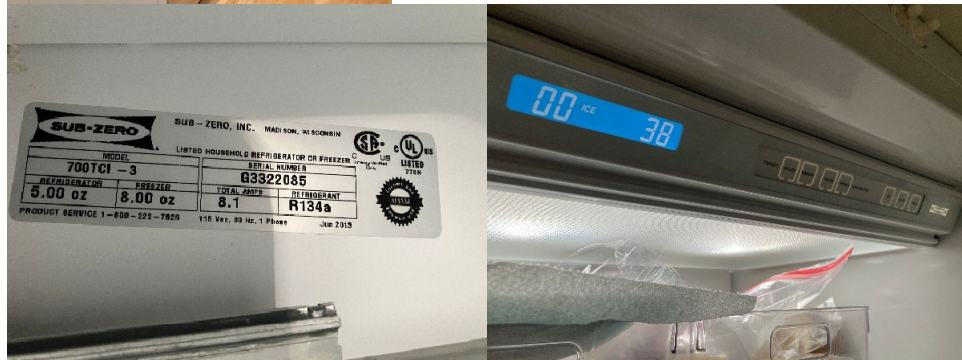
> A built-in “Sub-Zero” refrigerator/freezer with icemaker was installed. Manufactured in 2013.
